Research Article

Rotator Cuff Tendon Repair after Injury in Hyperlipidemic Swine Decreases Biomechanical Properties

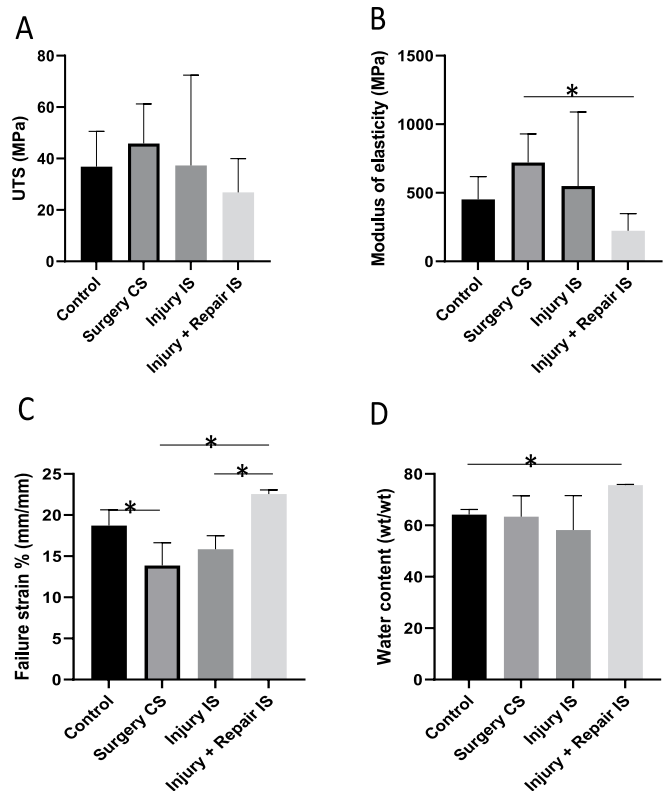
Figure 1: Mechanical properties and water content of tendon tissues. (A) Ultimate tensile strength, (B) Modulus of elasticity, (C) % Failure strain, (D) Water content. Control indicates the group of swine that received normal diet and no surgery. Surgery CS indicates uninjured tendon from contralateral side of swine that underwent either injury or injury + repair surgery. Injury IS indicating tendon from injury side that underwent injury. Injury + Repair IS indicating tendons from injury of swine that underwent Injury + Repair surgery. * Indicates significant difference ($p < 0.05$, student-t test).

The ultimate tensile strength (UTS), failure strain percentage, the modulus of elasticity (E), and water content are shown in Figure 1. The UTS of the tendon from the contralateral side was higher on both the injury model (group II) animals and the repair model (group III) animals (Figure 1A). These values were higher than injury side (injury model and repair model) and the control swines, but were not statistically significant. The tendons of the contralateral side had significantly higher elastic modulus than the repair model (Group III) animals. These values were also higher than injury side (injury model and repair model) and the control swines, but were not statistically significant (Figure 1B). The modulus of elasticity of the tendons on the injury side of the repair animals were lower than the control group of animals. The tendons on the injury side of the repair model (group III) had significantly higher failure strain percentage than the contralateral side and injured tendons (group II). Whereas

the failure strain percentage of the uninjured tendons of the contralateral side was significantly lower than the control group of animals (Figure 1C).

The water content of the tendon tissues is shown in Figure 1D. The injury side tendons of the repair model (group III) animals had the highest water content among the tested tendons which is significantly higher than the control group of animals. No significant difference in water content was observed among the other groups.

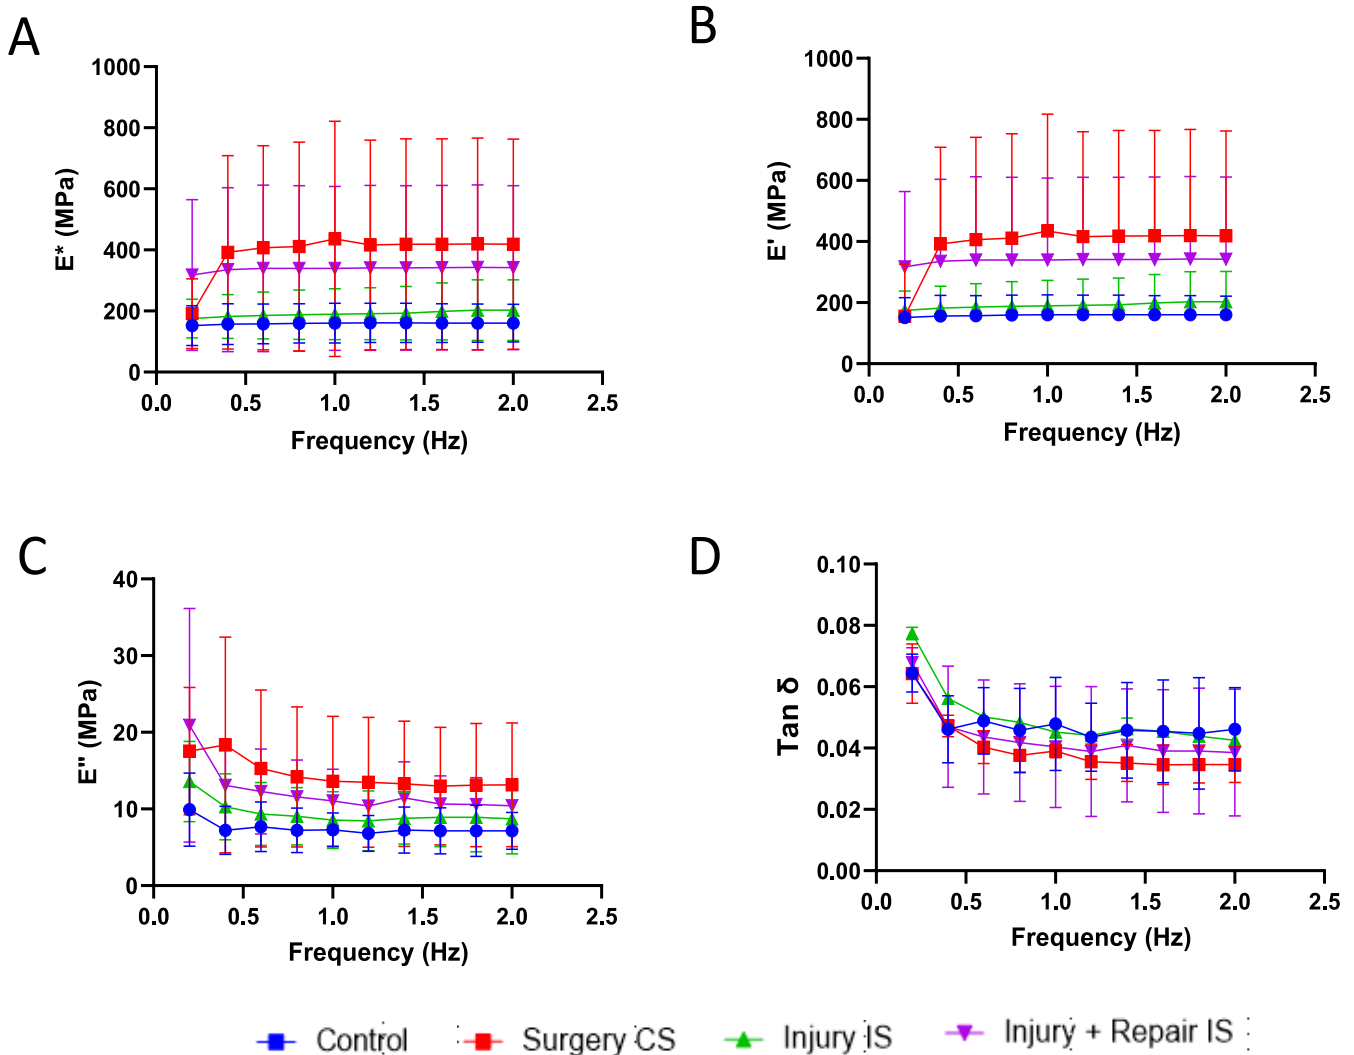
Figure 2: Viscoelastic properties of the tendon tissues at lower frequencies. (A) dynamic modulus (E^*), (B) storage modulus (E'), (C) loss modulus (E''), and (D) damping ability ($\text{Tan } \delta$). Control indicates the group of swine that received normal diet and no surgery. Surgery CS indicates uninjured tendon from contralateral side of swine that underwent either injury or injury + repair surgery. Injury IS indicating tendon from injury side that underwent injury. Injury + Repair IS indicating tendons from injury of swine that underwent Injury + Repair surgery.

The viscoelastic properties recorded at low frequencies are shown in Figure 2. The dynamic modulus and storage modulus increased with increase in frequency at the tested low frequencies while the loss modulus and the damping ability reduced with increasing frequencies. The dynamic modulus and storage modulus of the tendons on the contralateral side of the injury model (group II) and repair model (group

III), were higher than control group of swines but were not statistically significant (Figure 2A,2B). The loss modulus and damping ability ($\text{Tan } \delta$) did not show any significant difference between groups (Figure 2C,2D). The viscoelastic properties recorded at higher frequencies are shown in Figure 3. The dynamic modulus and storage modulus increased with the increase in frequency for all the tested tendons (Figure 3A,3B). Loss modulus and damping ability decreased initially at low frequencies and increased with increase in frequencies (Figure 3C,3D). The differences in viscoelastic properties at the respective frequencies were not statistically significant.

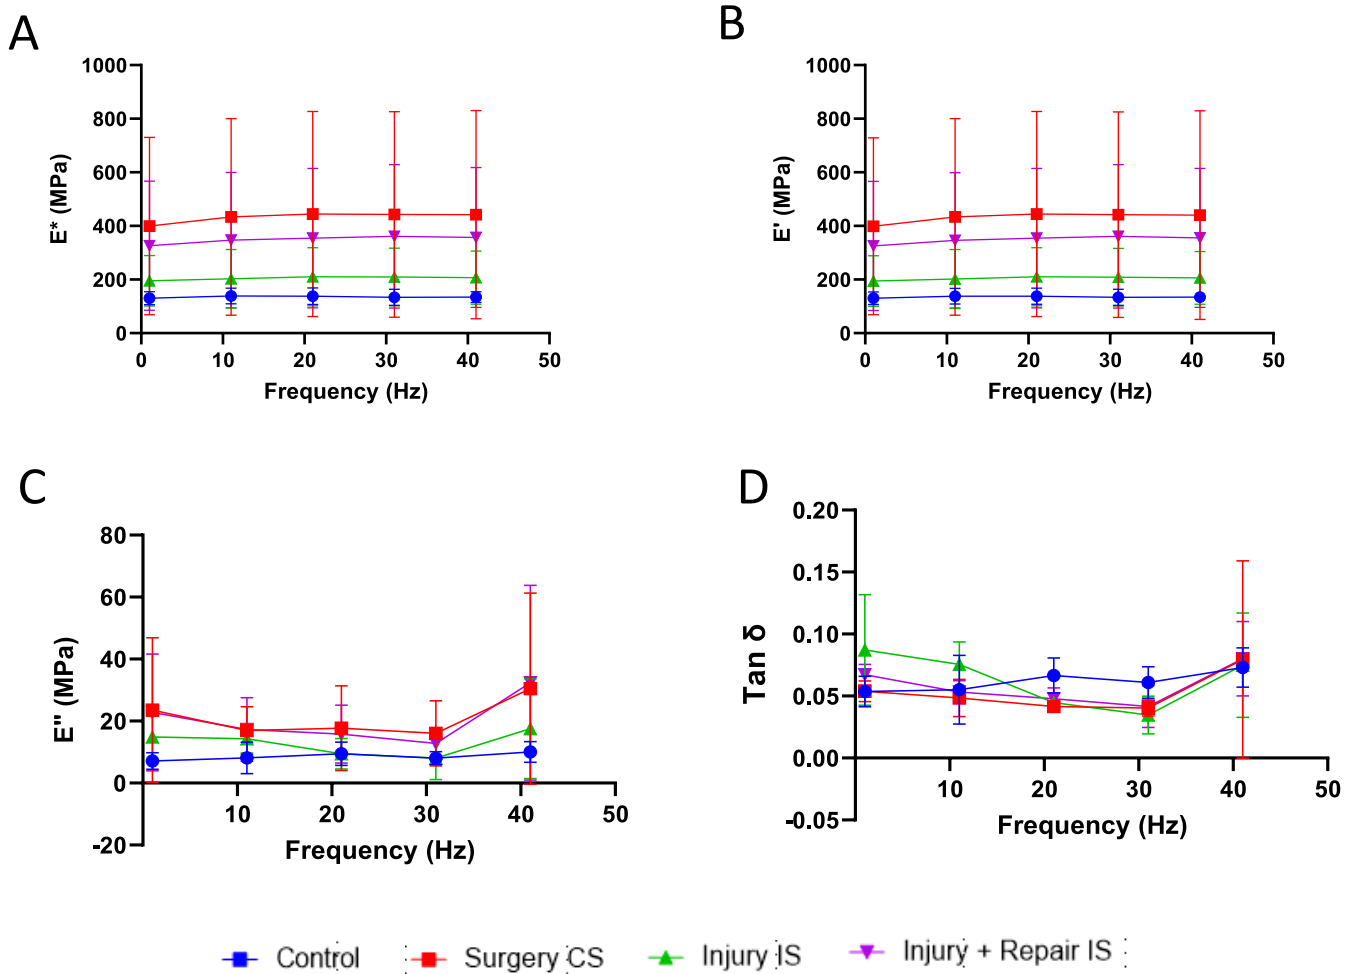
Figure 3: Viscoelastic properties of the tendon tissues at higher frequencies. (A) dynamic modulus (E^*), (B) storage modulus (E'), (C) loss modulus (E'') and (D) damping ability ($\text{Tan } \delta$). Control indicates the group of swine that received normal diet and no surgery. Surgery CS indicates uninjured tendon from contralateral side of swine that underwent either injury or injury + repair surgery. Injury IS indicating tendon from injury side that underwent injury. Injury + Repair IS indicating tendons from injury of swine that underwent Injury + Repair surgery.

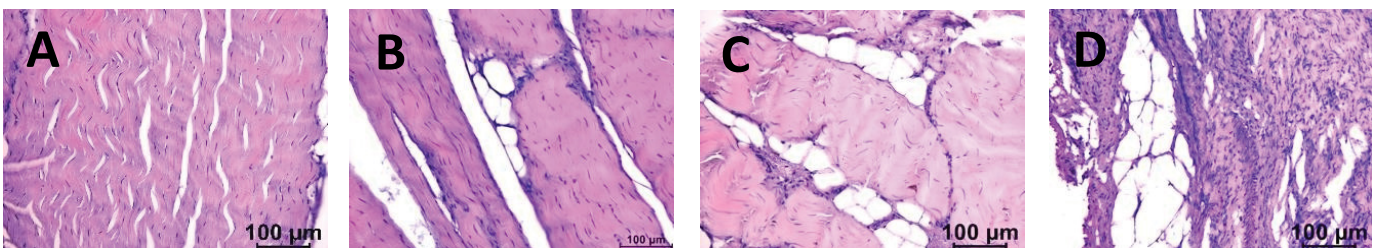
Figure 4: Representative image of tendon histology (H&E). (A) Control, (B) Surgery CS, (C) Injury IS, (D) Injury + Repair IS. Control indicates the group of swine that received normal diet and no surgery. Surgery CS indicates uninjured tendon from contralateral side of swine that underwent either injury or injury + repair surgery. Injury IS indicating tendon from injury side that underwent injury. Injury + Repair IS indicating tendons from injury of swine that underwent Injury + Repair surgery. The images were acquired in 20x magnification.

The representative images of H&E staining of the tendon tissue are shown in Figure 4. The tendons of the control

group had cells with elongated nucleus, tenocytes among the longitudinally arranged collagen fibers and extracellular matrix (ECM) was observed to be intact. The hyperlipidemic (group II and group III) animals were presented with the presence of fat infiltration, inflammatory cells, and actively dividing cells with rounded nucleus. We could observe clusters of inflammatory and dividing cells on the injury side of the repair model (group III) than the contralateral side of the repair model. The injury model (group II) had presented with less inflammatory cells in the injury side than the contralateral side but had fatty infiltration. Even though there were inflammatory cells and fatty infiltration, the tendons of the contralateral side had a better ECM organization than the injury side which was similar to the control group.
